# Lolo Creek Pilot Basin Study - Summary

## Part I: Hydrology and Water Use 2016 - 2019

Presentation by Todd Blythe, Water Management Bureau, DNRC  
July 6, 2021

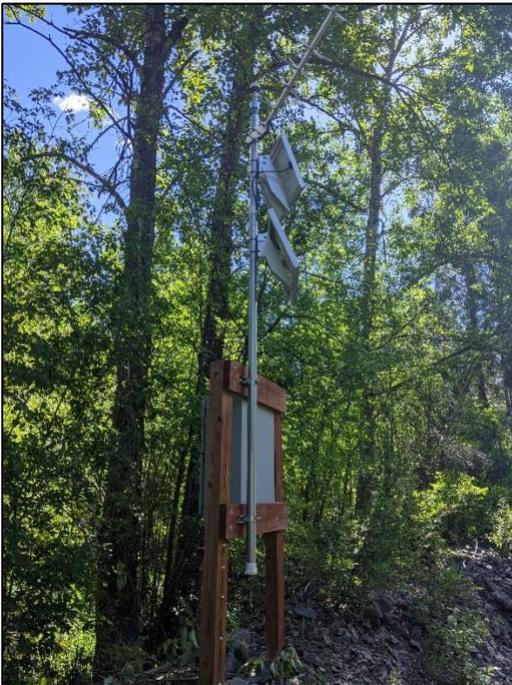
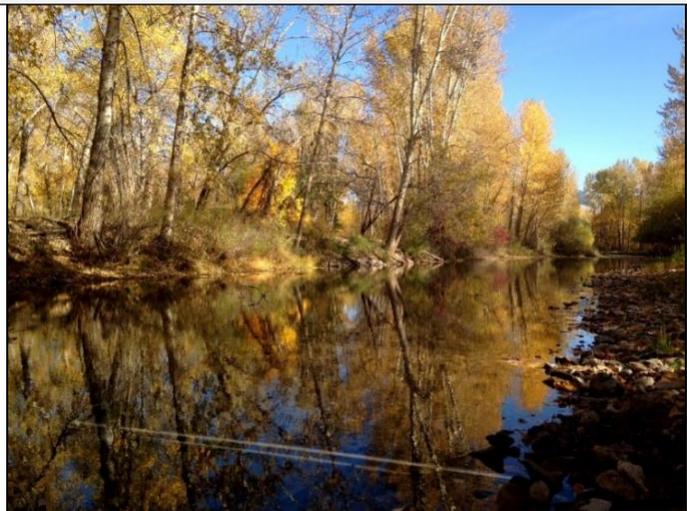
### Real-time gaging station on Lolo Creek at Hwy 93.

*Left* – Gage house holds equipment that sends data to DNRC database via satellite every 15 minutes.

*Below* – bubbler at the end of orifice line (shown under water) uses pressurized gas to measure changes in water elevation.

This project was made possible in part by DNRC's Stream Gage Program. The Program was initiated in 2015 in response to a State Water Plan recommendation to develop a network of year-round, real-time stream gages and compile and disseminate streamflow data from key locations around the state. The U.S. Geological Survey (USGS) has a nation-wide network of stream gages, including over 200 in Montana, but these gages are more representative of larger rivers. DNRC's program complements the USGS network by providing flow data for smaller streams, tributaries, and canals. Currently, DNRC operates 29 gages throughout the state, and the Hwy 93 gage on Lolo Creek was the 6<sup>th</sup> gage installed as part of this effort.
